THE NAVAJO NATION
Division of Natural Resources
Navajo Abandoned Mine Lands Reclamation Program (NAMLRP)

Scope of Work for the NAMLRP Projects:

Cameron 6 AML Project - NA0175; alternative 1

NA-CITS DIKE REPAIR

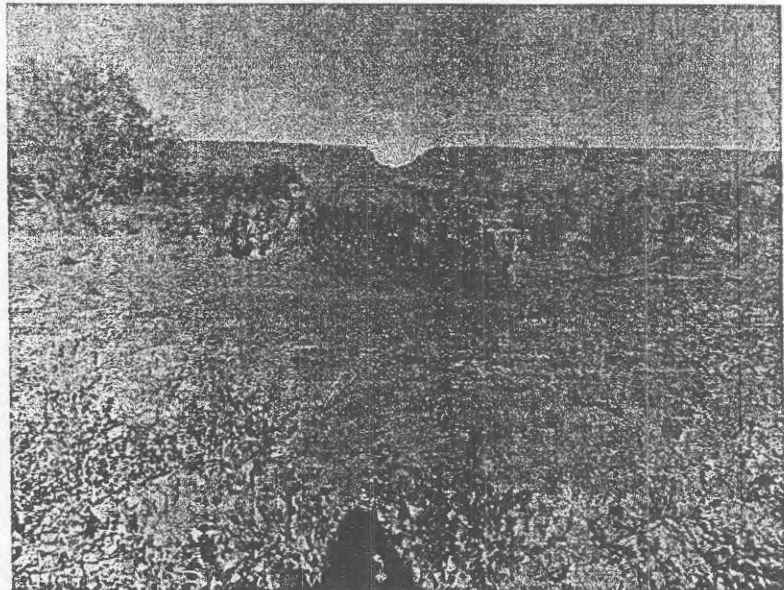
Photo #1:

Looking to the west, closeup of the breached dike area. The dike has failed by undercutting. Per the scheduled scope of work, this area will be fully excavated and backfilled. An additional 10 feet wide of material will be utilized to reinforce this dike. The upgradient clay sediment will be utilized as a source of borrow material. All slopes will be contoured to blend with the natural topography.

Due to changes being recommended by the U.S. Army Corp, changes to this project have been initiated. This project involves the repair/maintenance of a dike. The man-made dike has breached and no longer holds water. The dike will be repaired with upgradient clay material properly compacted. Borrow material will be excavated to rebuild and expand the dike by 10 feet wide. Approximately 8,000 cubic yards of material will be excavated from the upland project boundary, thus the expected impacted area will be less than 2.0 acres. Since this is an excavation process, very little to no discharge of material is expected from this operation. This area is also located within an area of past NAMLRP projects. The associated tributaries lead into the Little Colorado River, which is over 0.5 mile away to the west. Total projected time within this area is estimated at 30 calendar days.

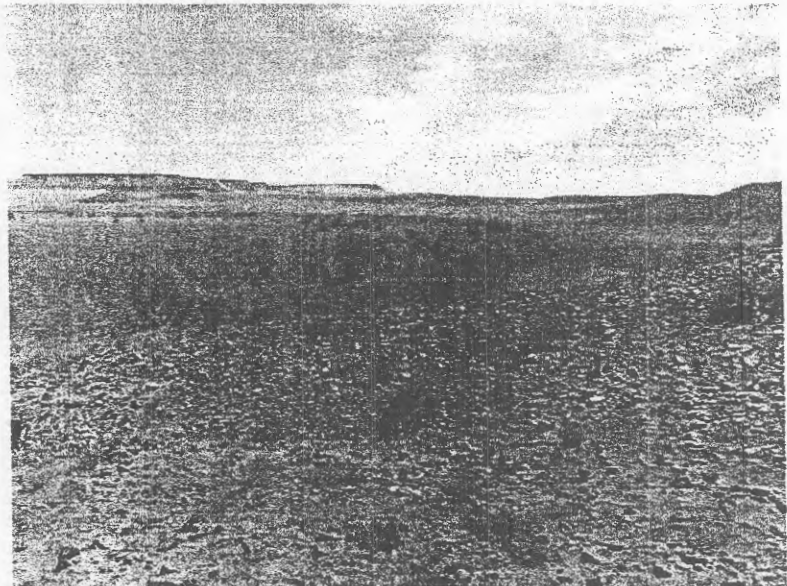
Photo #2:

Looking to the east from the edge of the southern dike, at the new source of upland borrow material. Per the scheduled scope of work, this area will be excavated and transported to the dike. An additional 10 feet wide of material will be utilized to reinforce this dike. This is in an area that was previous disturbed by the reclamation of other NAMLRP project sites. All slopes will be contoured to blend with the natural topography.

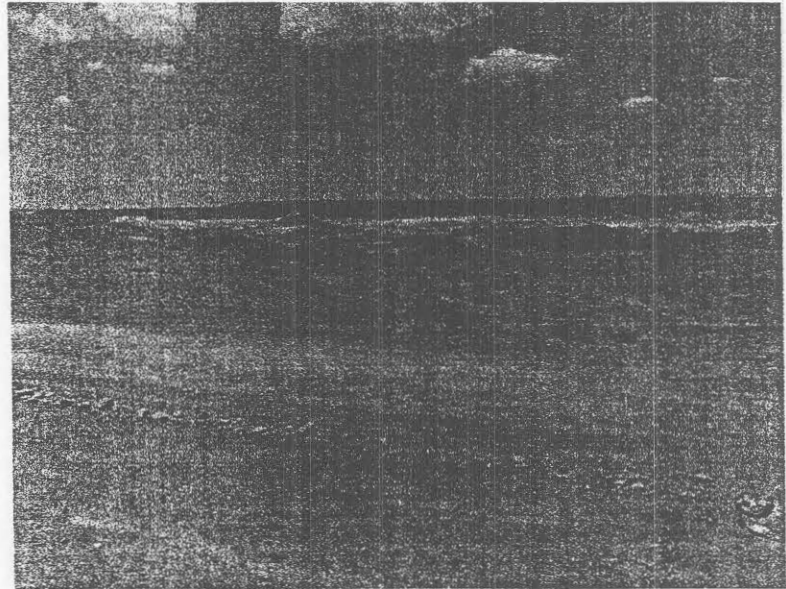
Photo #1:

Looking to the northwest. The man-made stock pond and associated vegetation. Per the scope of work, this area will be excavated as a source of borrow material and to increase the holding capacity of this area. This material will be transported to associated reclamation projects by dump trucks.

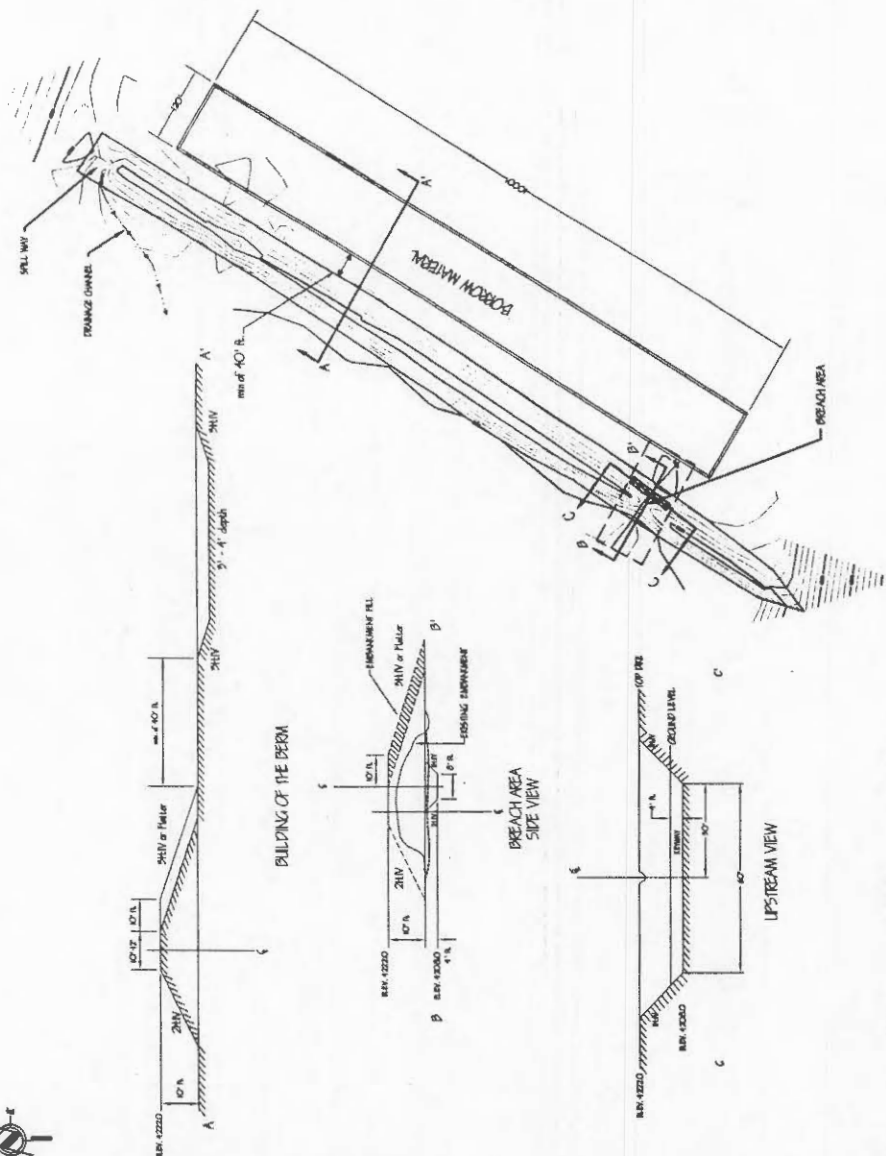
MAP NO. 15

Site NA-0175 (Dam Repair - Map No. 15); Scope of Work:

- D. Excavate the breached dam area to the following dimensions: 60 feet bottom base, 1h:1v side slopes, to a depth of 14 feet from the top elevation of the dam. Cut out an 8 feet wide by 4 feet deep, 1h:1v side slope, keyway within the excavated dam, for a length of 60 feet running parallel with the dam. Any unsuitable material (such as low density or organic material) will be disposed of away from the dam, upgradient and away from the borrow area.

- F. Start with the backfilling of the keyway by 8-inch lifts with proper compaction and moisture. Continue the backfilling of the keyway and the dam repair until the dam meets the required specifications, front slope of 3h:1v, backslope of 1h:1v, dam top width of 10 feet wide.

- H. Widen the dam an extra 10 feet for the full length of 1,250 linear feet, side slope of 3h:1v and compact accordingly. This work is estimated at 6,500 bcyds.
